ALERT SERVICE BULLETIN

STRUCTURE ASSEMBLY — FUSELAGE — REAR — INSPECTION, REPAIR AND INCORPORATION OF MOD N806 (REAR FAIRING STRENGTHENING)

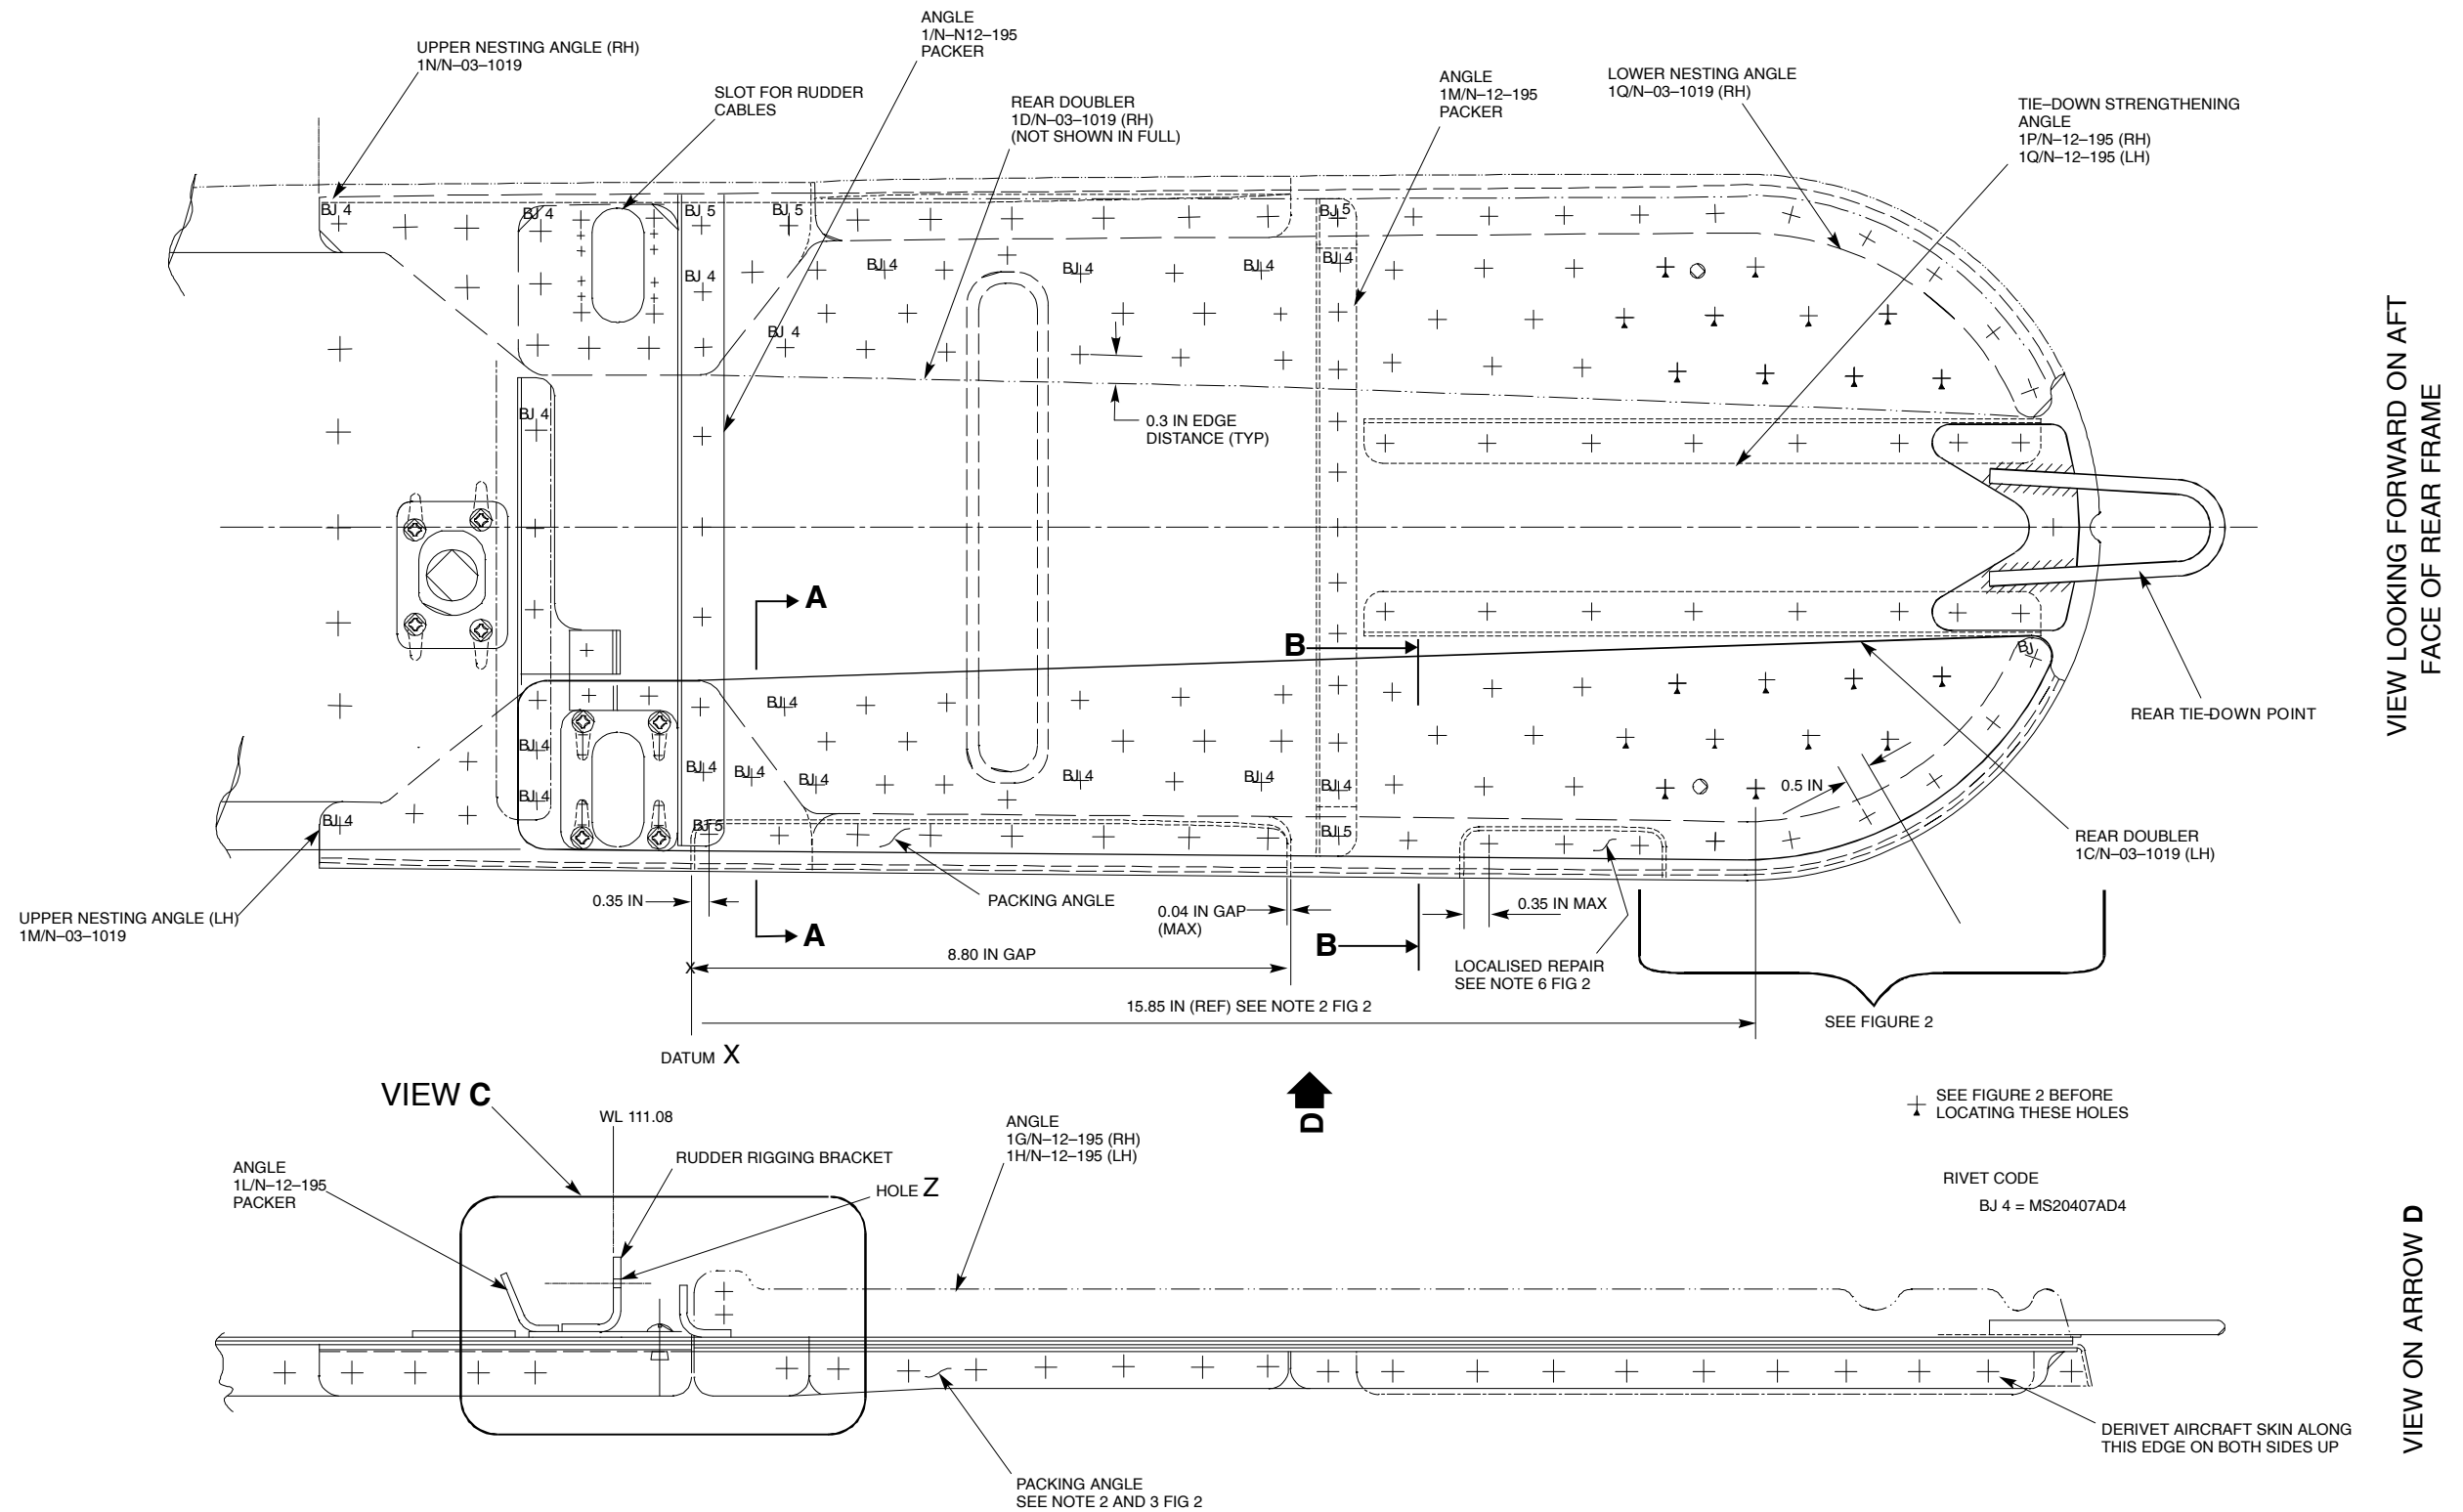
Figure 1 Rear Bulkhead Repair (ASTA Drawing N-03-1019)

A number of operators have reported cracks adjacent to the bulkhead rivet heads at STA 463.41 (N22 Series) and STA 508.41 (N24 Series). Frame failure may lead to a loss of structural integrity and a possible loss of aircraft control.

- (3) Cut rear bulkhead and remove damaged and cracked material between Datum 'X' and Datum 'Y' (Ref Figure 1).

- (6) To repair rear bulkhead between Datum 'X' and Datum 'Y', proceed as follows.
- (a) Position the packing angle PN 1A/N-03-1019 on LH side of the bulkhead as shown in Fig 1.

- (b) Position the packing angle PN 1B/N-03-1019 on RH side of the bulkhead as shown in Fig 1.
 - (c) Position the lower nesting angle PN 1P/N-03-1019 on LH and PN 1Q/N-03-1019 on RH side of the bulkhead as shown in Figure 2 Section B-B.

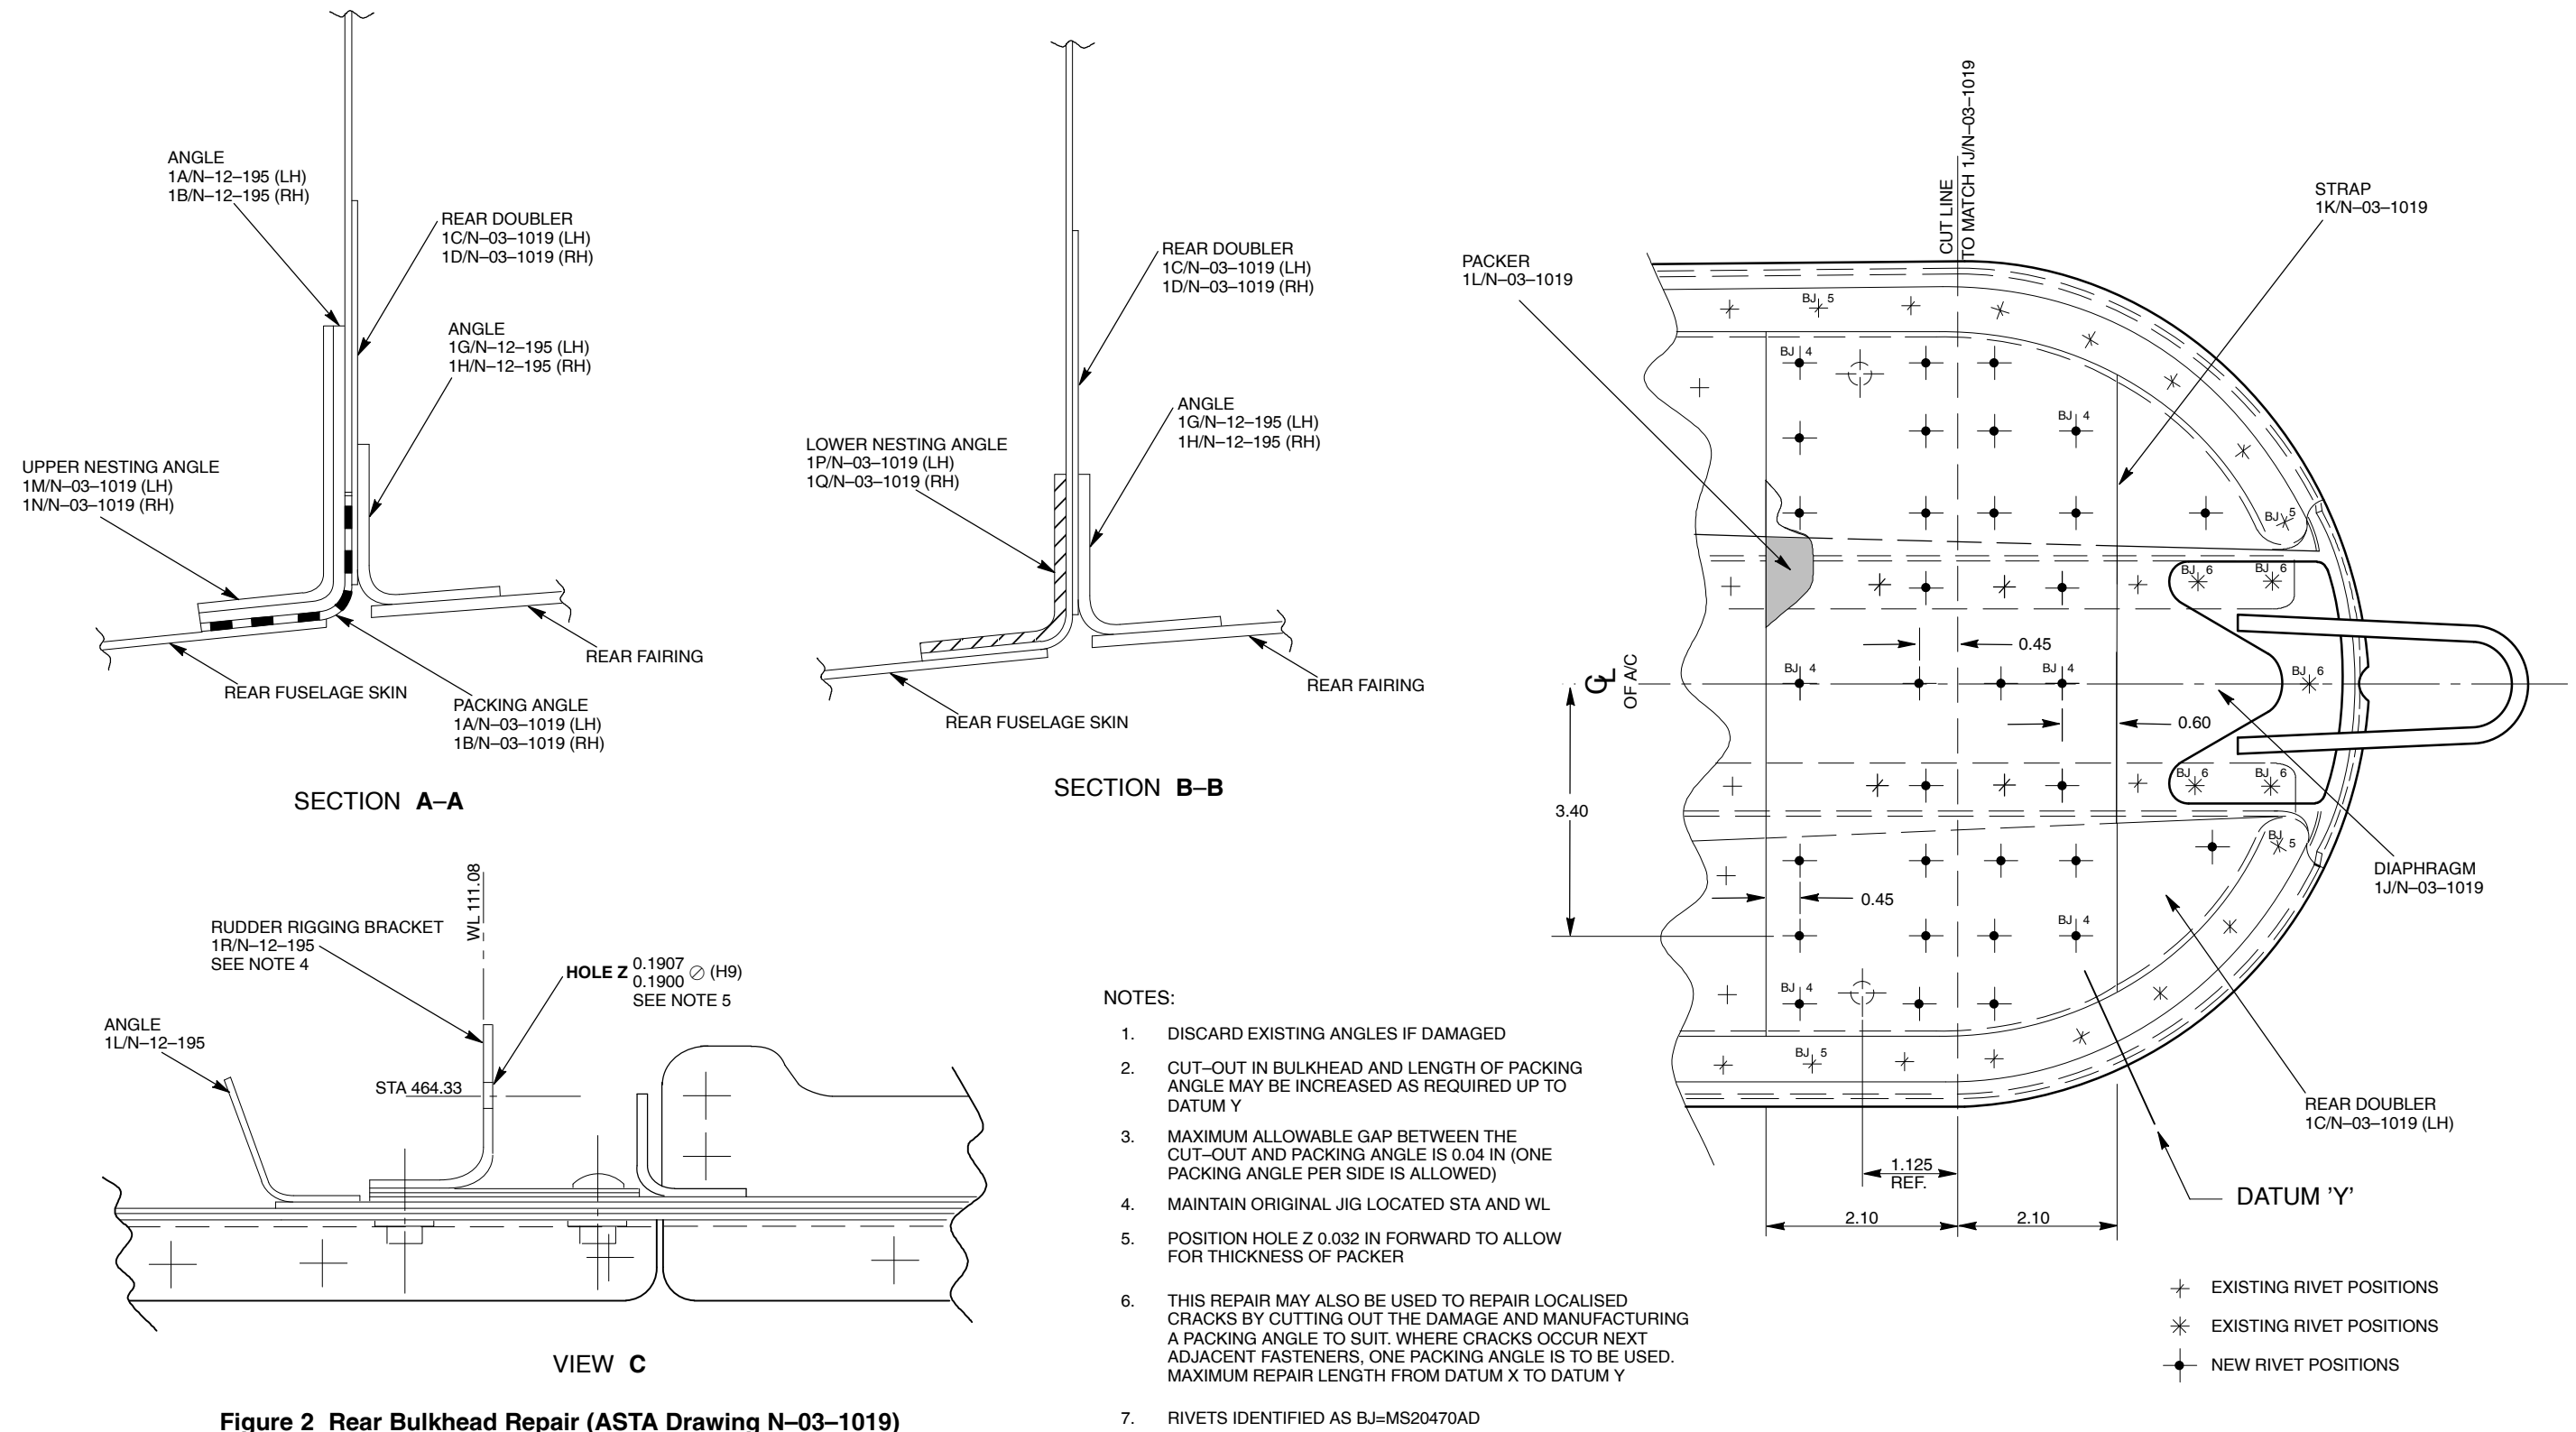
Figure 2 Rear Bulkhead Repair (ASTA Drawing N-03-1019)

- (4) If cracks and damage in the rear bulkhead are below Datum 'Y';
- (a) Remove the rear tie-down point and the two vertical tie-down strengthening angles PN 1P/N-12-195 RH and 1Q/N-12-195 LH (Ref Figure 1).

- (b) Cut out the bottom section of the rear bulkhead as shown in Figure 2.
- (5) Deburr the cut-out, remove any sharp edges and apply Alodine (Ref SRM Chap 51-30-00).

- (a) Position the diaphragm PN 1J/N-03-1019 as shown in Figure 2, drill rivet holes and skin pin progressively.
 - (b) Mark and pilot drill new rivet positions on the strap PN 1K/N-03-1019 using 1/16 in drill (Ref Figure 2).
