Nomad

SERVICE BULLETIN

STABILISERS — HORIZONTAL STABILISER — ACCESS PANEL INTERCOSTAL ANGLES (MOD N407) AND UPPER AND LOWER SKINS — INSPECTION

NMD-55-34

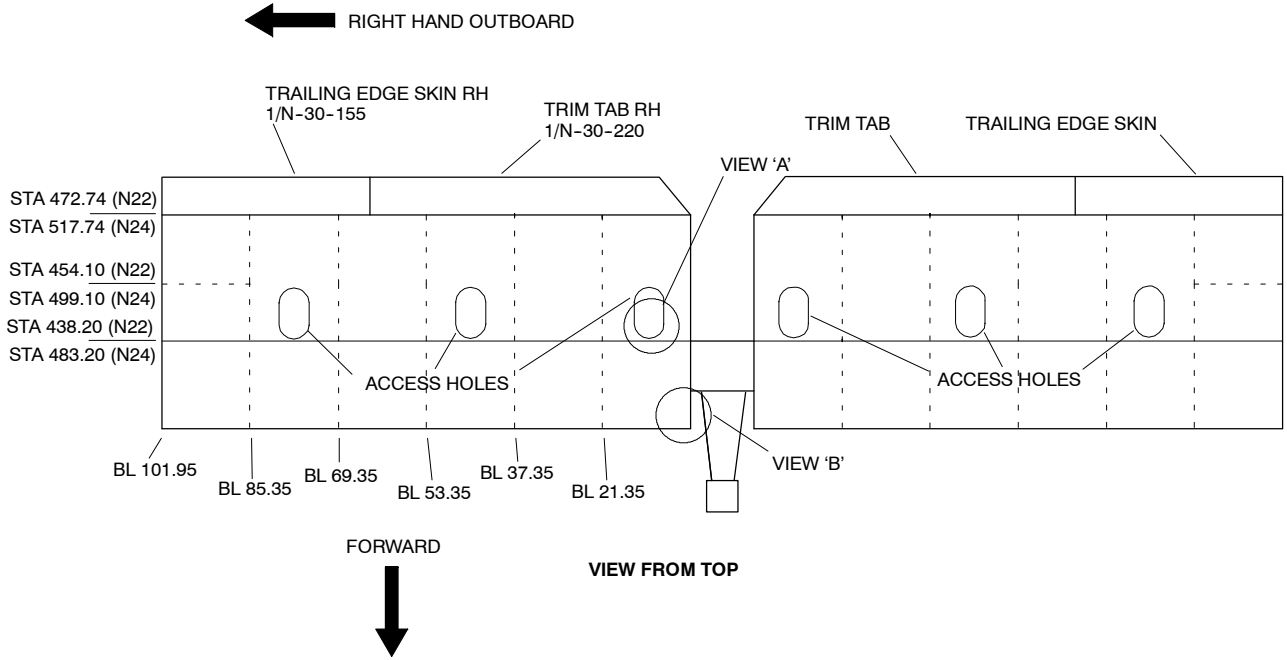
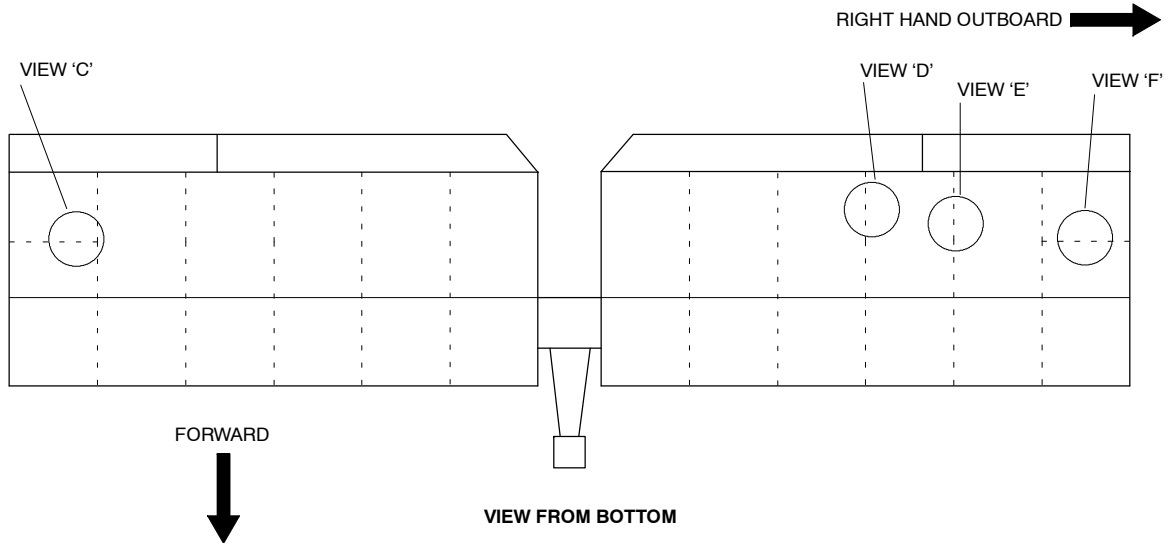
Figure 1 (Sheet 1) Horizontal Stabiliser - Cracking of Upper and Lower Skins

A number of operator Defect Reports have been received which have indicated a problem with cracking of the horizontal stabiliser upper and lower skin (Ref Fig 1, Sht 1 & 2), at the ends of the horizontal stabiliser access hole intercostal angles PN 1D/N-03-596, PN 1E/N-03-596, PN 1F/N-03-596 and PN 1G/N-03-596 (Ref Fig 4 and Fig 5) and in the horizontal stabiliser trailing edge channel (Ref Fig 3).

NOTE:
CRACKING OF THE SKIN SURFACES IS NOT RESTRICTED TO THE AREAS INDICATED IN THESE DRAWINGS AND CARE MUST BE GIVEN TO INSPECTING THE ENTIRE SKIN SURFACES.

- (1) Visually inspect the horizontal stabiliser upper and lower skin surfaces paying particular attention to those areas indicated in Figure 1.

Cracks detected on the skins of the horizontal stabiliser shall be repaired in accordance with the Structural Repair Manual, Chapter 55-10-11. Cracked intercostal angles (Refer to Figures 4 and 5) shall be repaired by replacement.

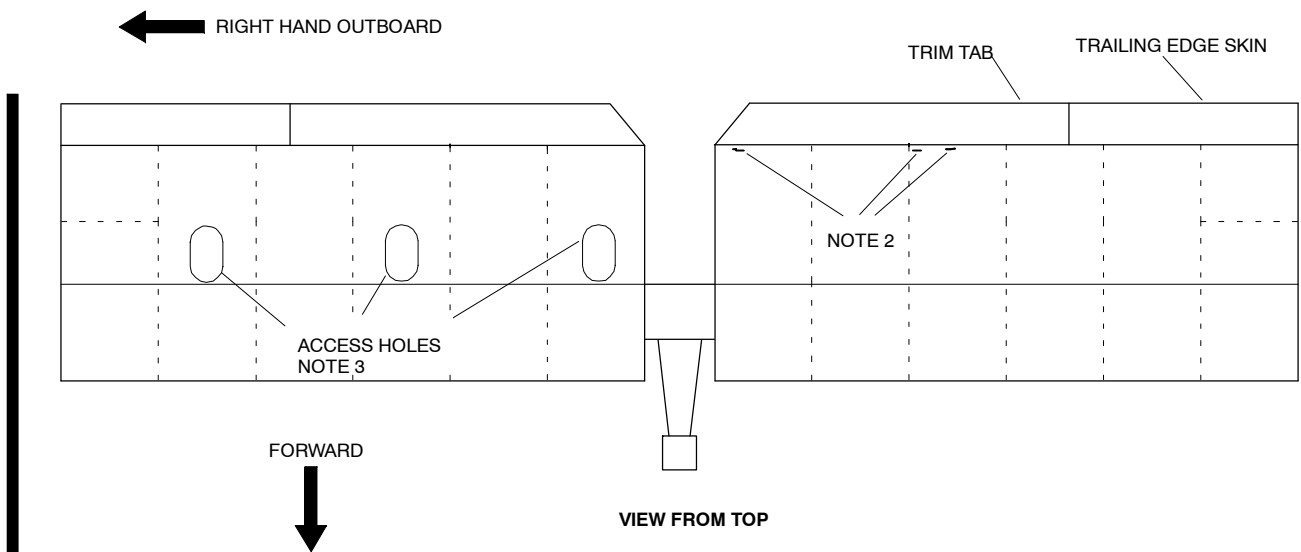
Figure 2 Cracking in Horizontal Stabiliser Trim Tab Hinge attachment

NOTE 2 : CRACKS HAVE BEEN FOUND AT THE LH TRIM TAB ATTACHMENT TO THE HORIZONTAL STABILISER. THE CRACKS ARE IN THE TOP SURFACE OF THE HORIZONTAL STABILISER AT THE 5TH, 28TH AND 29TH RIVETS STARTING FROM INBOARD

- (2) Perform a visual inspection for cracking in the top surface of the horizontal stabiliser trim tab hinge attachment to the rear spar (Ref Fig 2).
- (3) Disconnect the trim tab from the trim tab control rod in order to provide clear access.
- (4) Lift each of the trim tabs in turn so that the lower trailing edge rear spar channel may be clearly seen and inspect for any cracking along its length (Ref Fig 3).
- (5) Lift each of the trim tabs in turn and inspect the horizontal stabiliser trailing edge along full length for cracks.
- (6) Visually inspect entire surface of LH and RH tip fairings, paying particular attention to attachment edge, for cracks.
- (7) Visually inspect horizontal stabiliser trailing edge upper skin between BL 69.35 and BL 101.95 for cracks (Ref Fig 1).
- (8) Remove each of the six horizontal stabiliser upper surface access panels (Ref Fig 2).

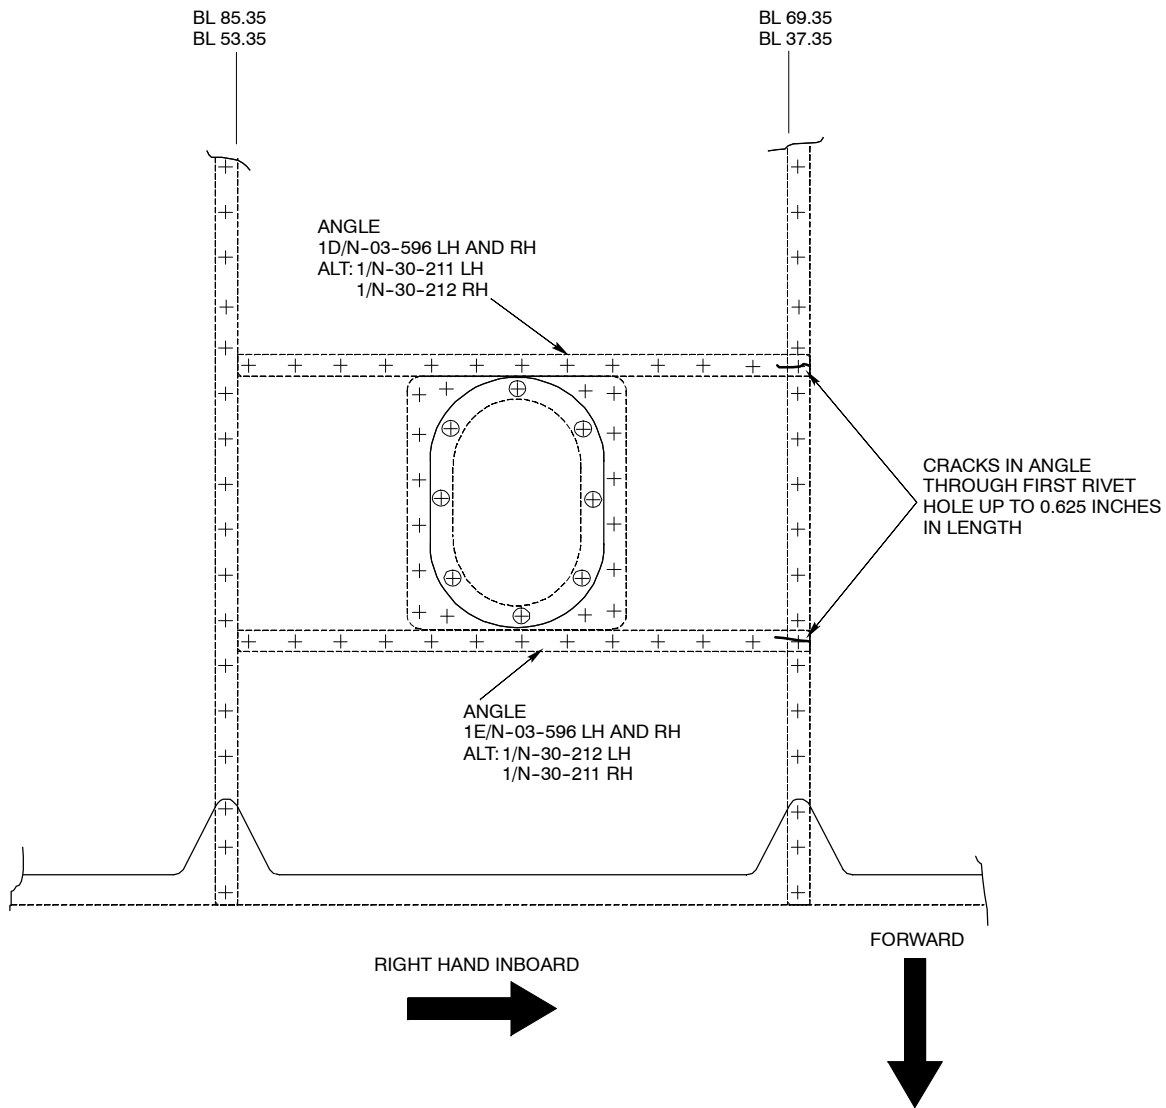
Figure 5 Cracking of Outboard Access Hole Intercostal Angles in Horizontal Stabiliser

NOTE: CRACKS HAVE BEEN FOUND IN THE ANGLES
SUPPORTING BOTH OF THE ACCESS HOLES
