# Service Bulletin

Throttle Cable Inspection.

All GA8 aircraft, serial numbers 8-00-004 through 8-03-027.

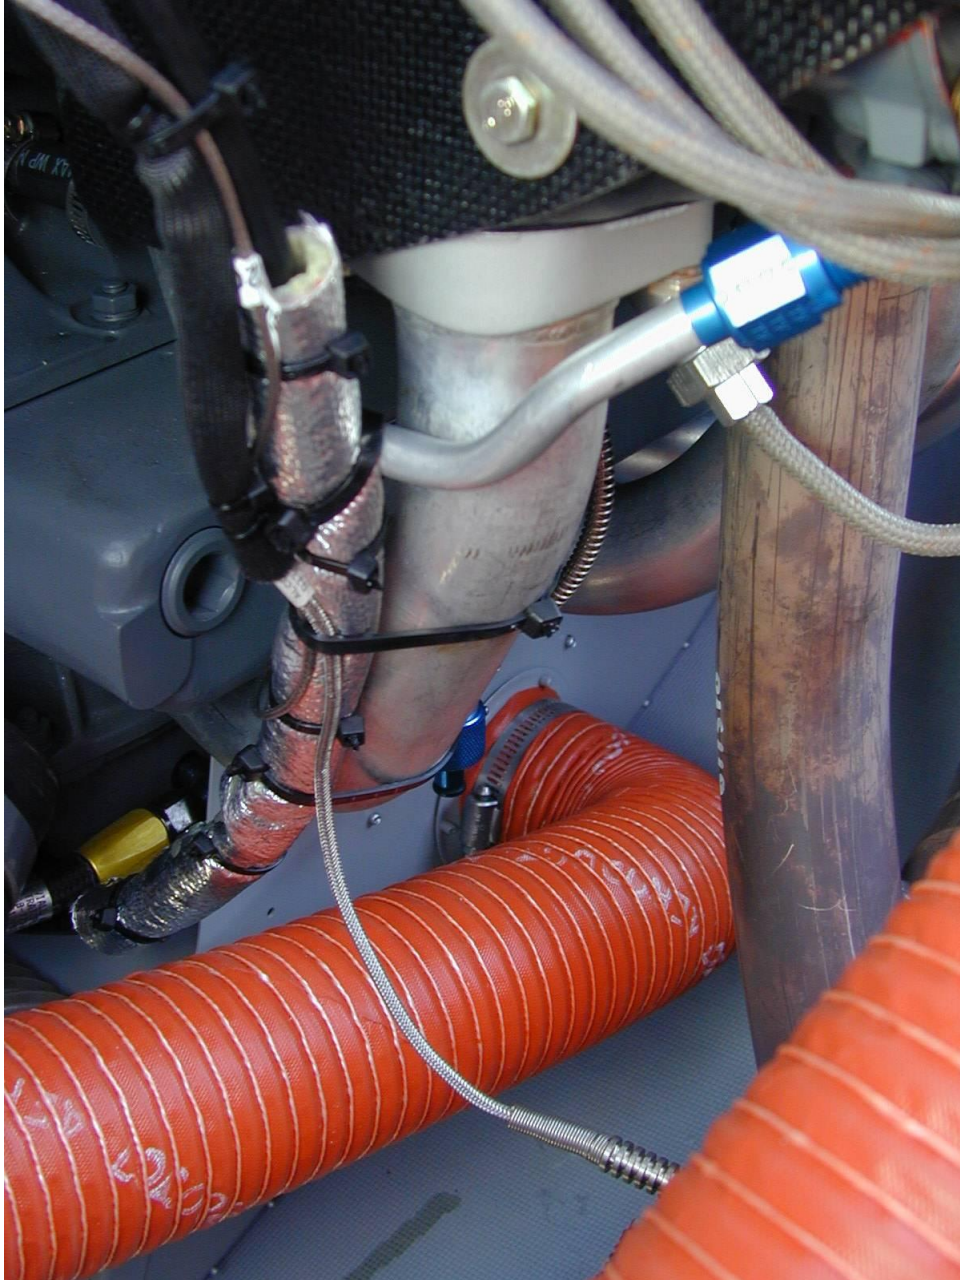
Figure 1

An aircraft in service has shown signs of degradation of the outer sheave of the throttle cable in the engine compartment in the vicinity of the engine cylinder number 5.

1. Remove right hand engine cowl door.
2. Cut tie wrap holding the throttle cable to engine cylinder No.5 inlet manifold.
3. Slide heat shield material along throttle cable until able to inspect the portion of normally covered cable. If the throttle cable outer sheave has deteriorated in any way, replace cable and Heat Shield Material before further flight [Order Gippsland Aeronautics P/N – GA8-761012-15 (Throttle Cable) and GA8-761022-21 (Heat Shield Material)].
4. Slide Heat Shield Material back in place adjacent to engine cylinder No.5 inlet manifold. Wrap supplied cloth (Item 1 - Throttle Cable Heat Reflective Cloth) around new or existing Heat Shield Material and tie wrap in place as shown below in Figure 1. **Ensure cable is secured to the aft side of the inlet manifold tube.**
