SB-GA8-2011-69

Issue 3

Service Bulletin

Modification of Co-pilot Control Column

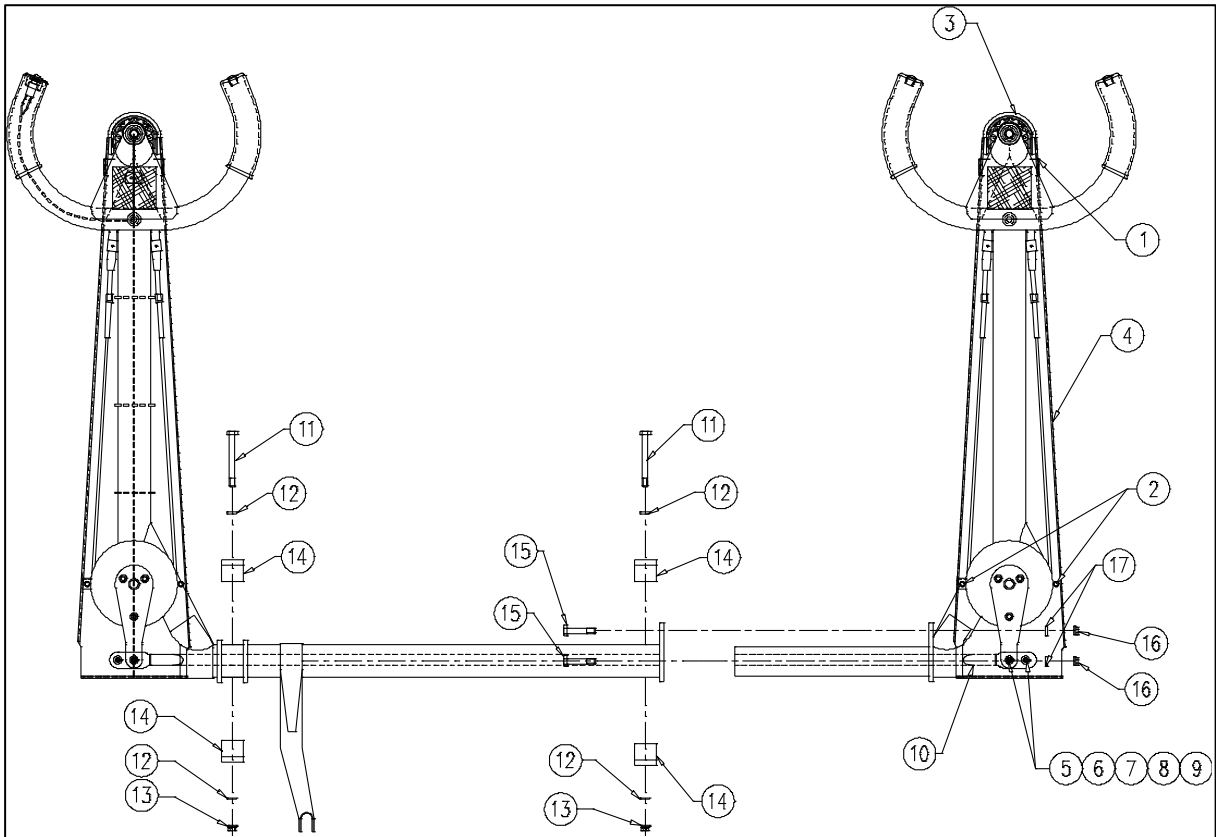
Figure 1 – Dual Control Column Removal

In order to make the removal/installation of co-pilot control column easier, this Service Bulletin provides the procedure for how to modify the co-pilot torque tube.

1. Loosen and remove the Screws (1), Screws (2) and then remove the Control Column Top Cover (3) and Control Column Cover (4);
2. Remove the Split Pins (5) and loosen and remove the Clevis Bolts (6), Nuts (7), Washers (8) and Bushings (9) to disconnect the Dual Control Aileron Link Rod (10) from the right hand aileron operating cable and right hand control column;

3. Remove the forward inboard floor access panels to gain access to the left and right hand control column bearing block attachment bolts and nuts;
4. Loosen and remove the Bolts (11), Washers (12) and Nuts (13) and remove the four Half Bearing Blocks (14);

5. Loosen and remove the Bolts (15), Nuts (16) and Washers (17);
6. Disconnect the co-pilot PTT loom (if installed);
7. Remove the right hand control column;

10. After the drying time of 2 hours, place the right hand control column back to the original assembly;
11. Re-install the four Half Bearing Blocks (14) by using the original hardware and torqueing the Bolts (11) to 70 in.lb;

12. Re-install the forward inboard floor access panel;
13. Re-install the Dual Control Aileron Link Rod (10) to the right hand aileron operating cable by using original hardware;
